ST STEPHEN'S CHURCH
JERVOIS ROAD
PONSONBY

CONSERVATION PLAN

MATTHEWS & MATTHEWS ARCHITECTS LTD

October 2010

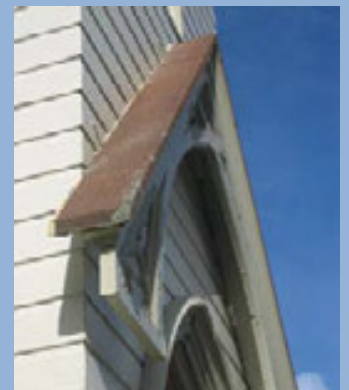
Figure 27: Roof details. Top: North gable (finial missing). Middle: Eaves Brackets Bottom: Porch gable detail. Photographs KS 2010.

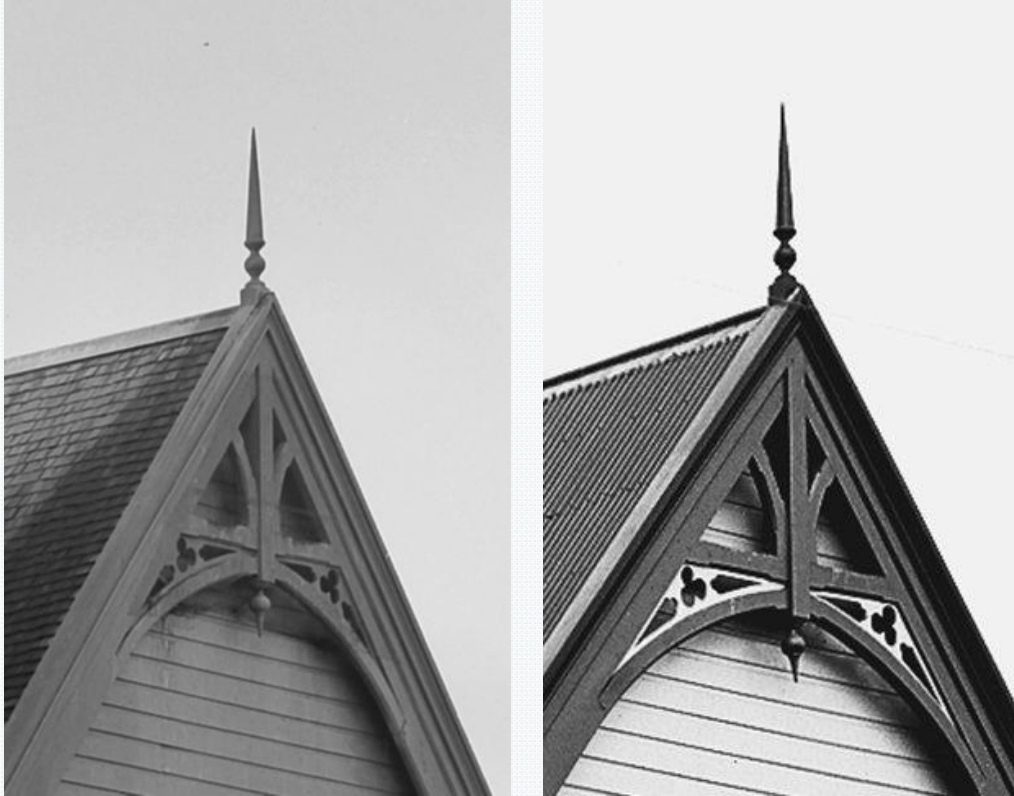
Figure 28: Detail of south main gable finial and timber decorative mouldings. Left: Detail from Figure 2, shows the building circa 1880. Right: Detail from Figure 11, shows the building immediately after the 1907 additions with the detailing at this stage picked out in more contrasting colours. Some of the detailed original mouldings and cappings have since been lost.

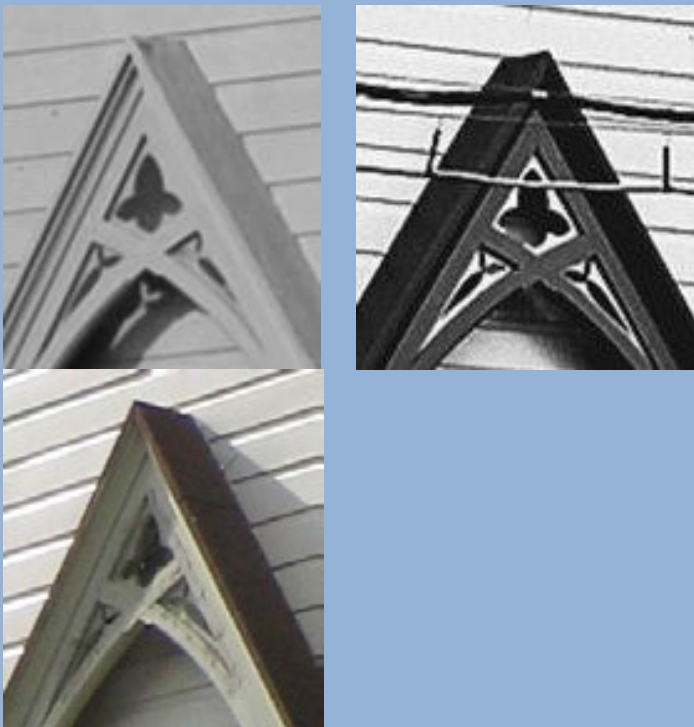
Figure 29: Decorative gable detail from left to right showing respectively 1889, 1907 and 2010. 2010 the detailing is covered with wire netting and the capping with decramastic roof sheeting. Details from Figure 2 and 11 and recent 2010 photograph.

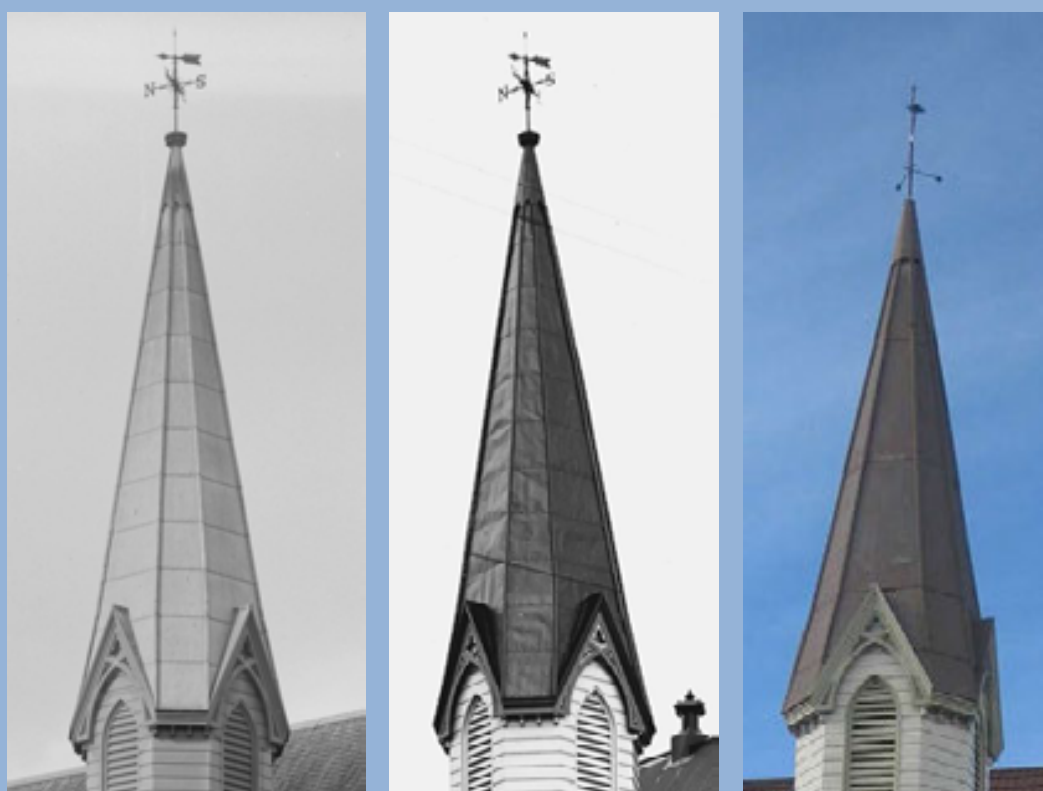
Figure 30: Left: Detail from 1880s, showing roof of spire with original roof sheeting, see also original timber shingle roof to main roof of 1879 building. Middle: detail of spire, from 1907 photograph. Note the different detailing in the size of the sheets and the missing detail on the weathervane. Right: Roof spire in 2010 with 1963 galvanised roof sheets and damaged weather vane. Source: KS 2010.

Item	Rating
Spire Roof Overall	A
1963 galvanized iron roof sheeting to spire.	c
Decorative gable timber detailing, eaves brackets and louvres.	a
Wire netting.	intr
Weather vane detailing.	rr
Weather vane to spire. (This has been modified and is missing parts.)	a/rr

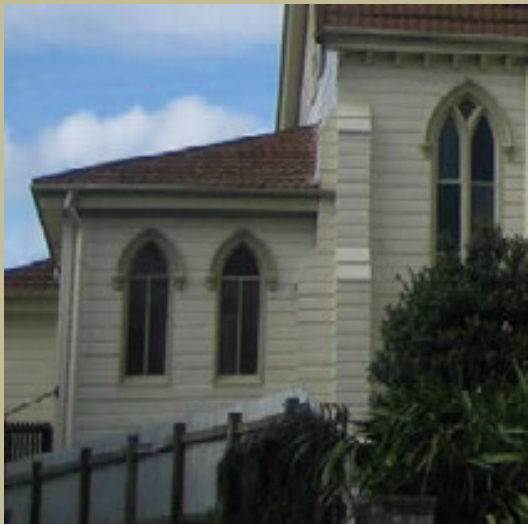
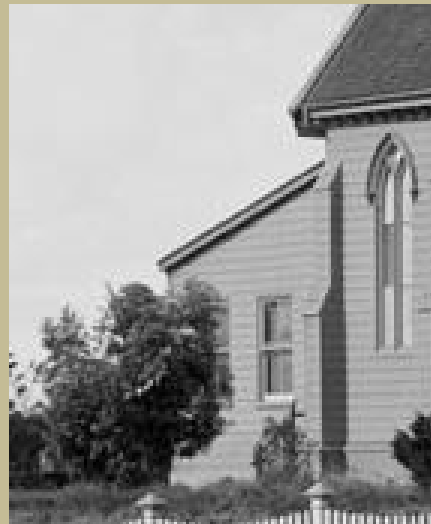
Figure 32: Detail of the vestry lean-to 2010 and 1880s. Left: Photograph showing the vestry with later lancet windows and hipped roof. Source: Photograph KS 2010. Right: Detail from 1880s photograph Figure 2, detail showing the vestry in its original simpler form with sash windows and skillion roof, one of the sash windows may have been re-used elsewhere in the vestry with later changes to the building.

Item	Rating
Roof of vestry lean-to. (This was originally a skillion roof with additions this has since been altered into a partly hipped configuration.)	B
Decramastic roof finish.	nil
Rainwater spouting and downpipes, there is a combination of PVC and galvanized iron pipes. These were replaced in the 1963 renovations.	nil

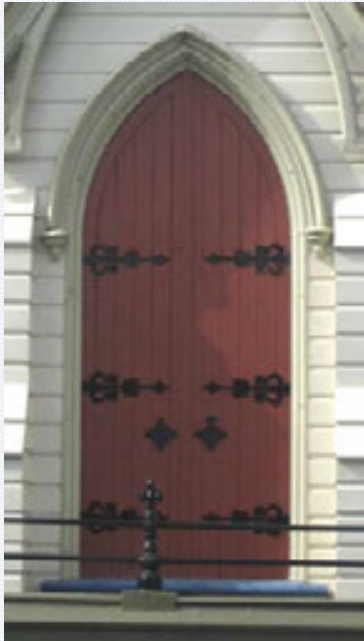
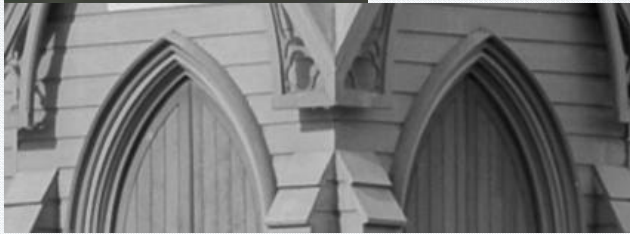
Item		Rating
Exterior lancet doors		A
Exterior lancet doors Condition note: The drip moulding to the west transept entry door is pulling away and repair will be needed.	There are a total of 6 main entry/exit double lancet doors to the church. Two to the porch, one for each transept and two into the base of the spire tower. Minutes indicate that these were originally varnished. ⁹⁴ They are currently painted on the exterior. The interior of the doors is a timber shellac finish. Note: The doors on the south side into the porch and spire tower entrance were shortened slightly in 1907 when the floor level was raised on the south end to create a sloping floor in the church. Note: the top of the doors have been overlapped a ceiling estimated to have been inserted in the 1920s	a
	False perspex strap hinges to lancet doors. These imitate the original cast iron hinges but there is an extra set to each door.	Intr/rr

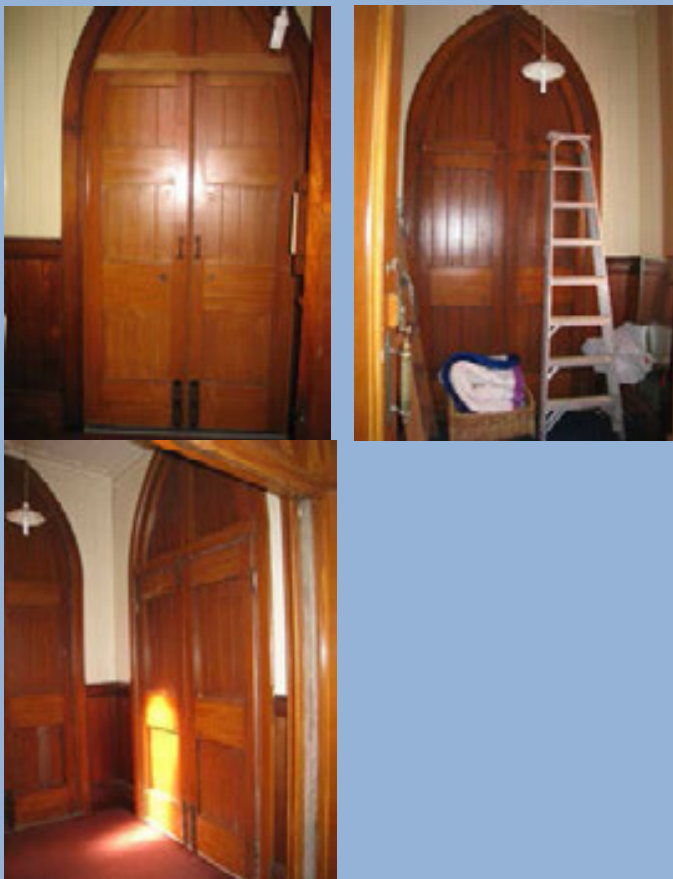
Figure 44: Detail of Transept, spire and east porch lancet double main entry doors. Some original door hardware remains such as the bolts, but the original door handles have been removed. Source: Photographs JM 2010.
