ST STEPHEN'S CHURCH
JERVOIS ROAD
PONSONBY

CONSERVATION PLAN

MATTHEWS & MATTHEWS ARCHITECTS LTD

October 2010

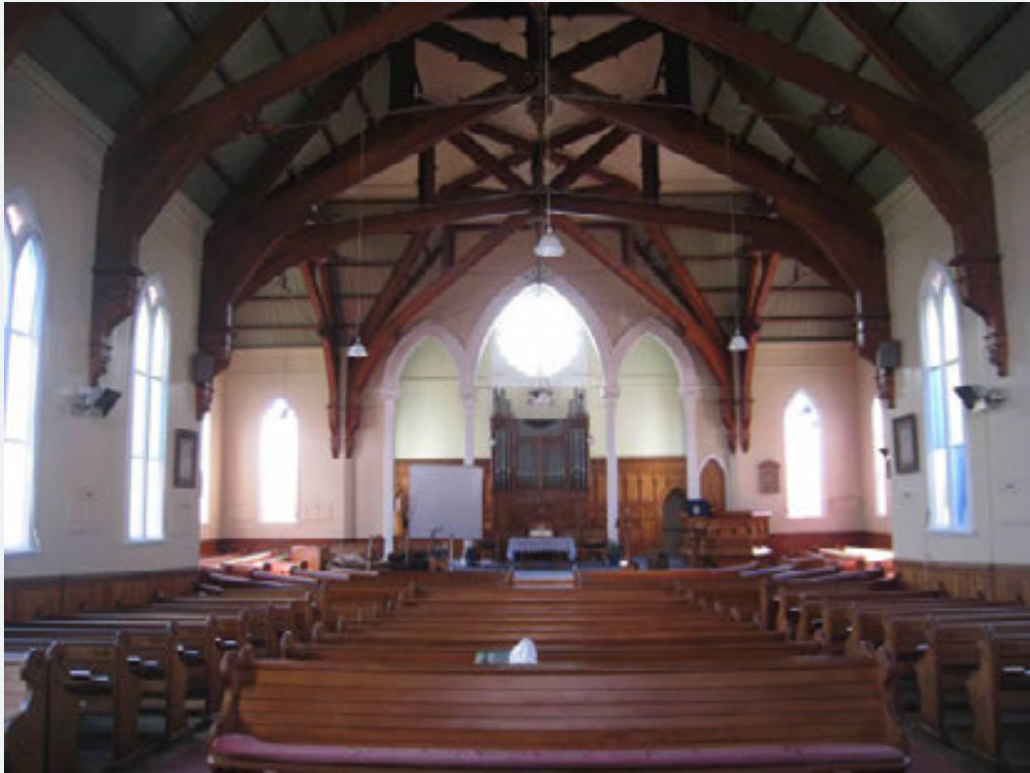
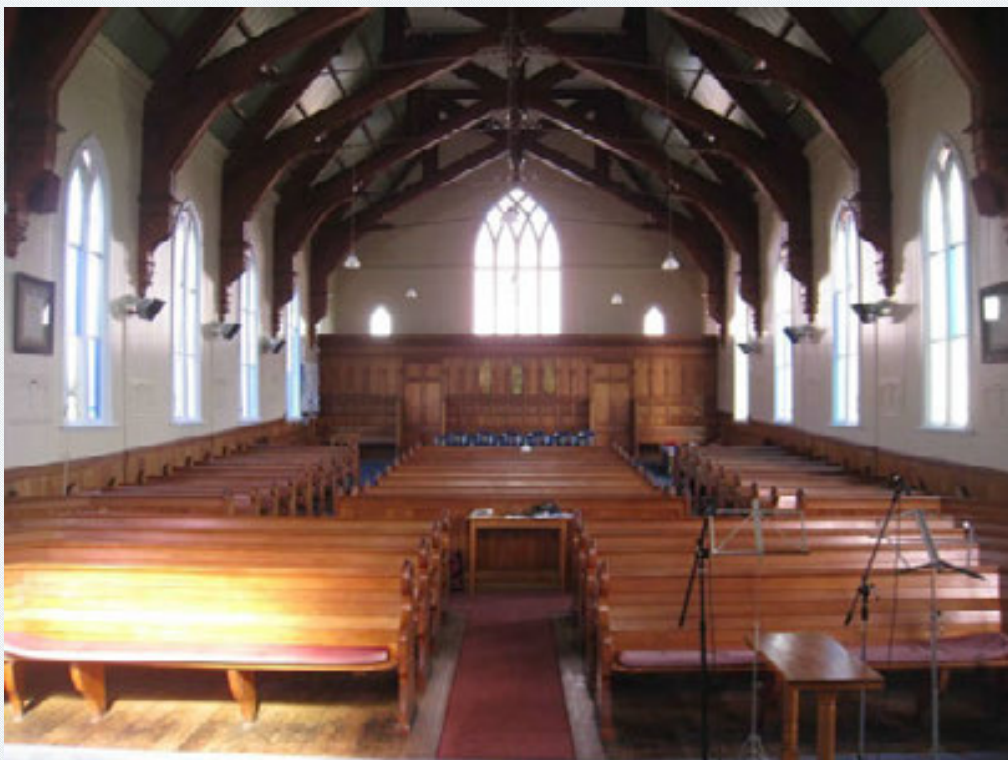
Figure 53: View towards the altar. Photograph JM 2010.

Figure 53: View towards the entrance. Photograph JM 2010.

Item	Rating
Church Interior Overall The church interior remains largely intact, following changes made in 1907. It incorporates the original 1879 nave (designed by Mahoney & Sons Architects) and alterations made in 1907 (designed by Robert Watt) when the transepts were added and the original north wall repositioned further north. The interior also retains elements added over time including timber screens/lobbies at the main entrances, the Croft organ donated in 1909 and furniture and fittings, many of which were gifted by or commemorate members of the congregation. Changes include relocation of the organ console to the west and removal of the choir pews, installation of the low stage around the altar, and repositioning of the pulpit. Some pews at the rear of the church have been removed, but otherwise the pews remain intact.	A

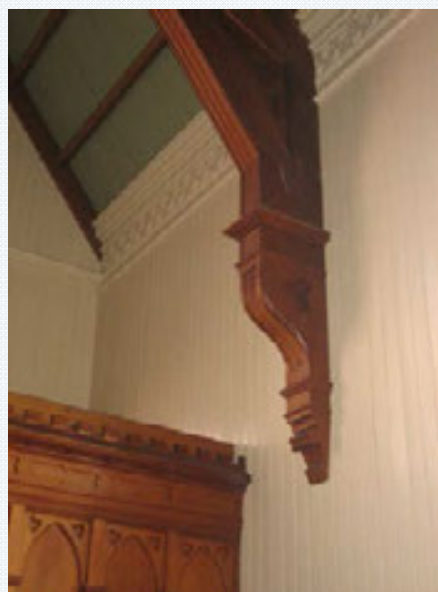
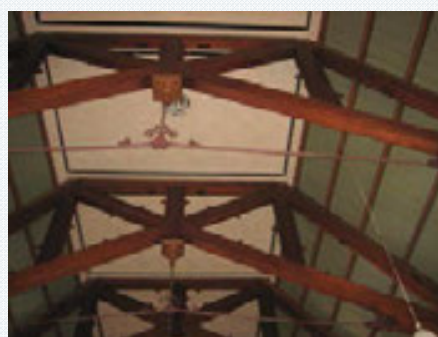
Item	Rating
Ceiling Overall	A
Flat central sections, 1907. Painted pressed metal ceiling tiles with stylized quatrefoil and trefoil detail in an Art Nouveau based style. It is likely that this would have been added in the 1907 alterations linked to the air vents (since removed as the ventilation proved to be too good. ⁹⁶)	a
Sloping ceilings. Painted beaded TG&V ceiling boards and exposed painted purlins. Dating from 1879 in the nave and 1907 in the transepts.	a
Trusses 1879 and 1907. Original scissor trusses with central post. Thorn detail in timber to truss members. Trusses supported on decorative timber brackets, which were modified in the 1907 additions. Five trusses along nave, two diagonally over the crossing and one to each transept.	a
Tie rods, estimated 1907. Original steel tie rods connect to base of each truss, decorative detail at central connection. These appear to have been added in the 1907 additions.	a

Figure 54: Top: Truss bracket detail also shows the elaborate frieze cornice detail added in 1907. Bottom: Ceiling showing decorative tie rods and flat pressed steel panels added in 1907. Source: Photograph KS 2010.

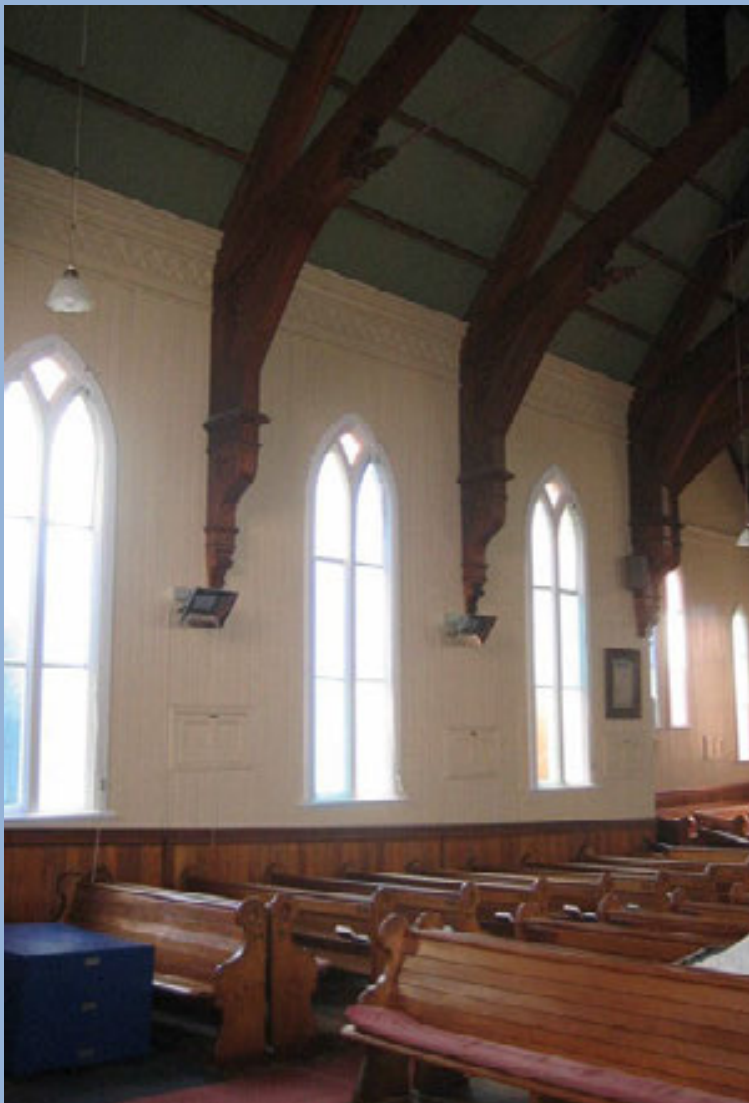
Item	Rating
Walls Overall	A
Frieze and cornice detail. The frieze was added in the 1907 additions. Timber moulding and frieze at top of walls with circular quatrefoil detail.	a
Wall linings 1907. Painted vertical TG&V, with dado applied over base. Circular bead at junction with ceiling. The wall linings replaced in the 1907 additions when the original 1879 horizontal boards were replaced with the current vertical boards.	a
Dado, 1879 in parts and 1907. Oiled or shellac finish TG&V boards.	a
Skirtings, 1879 in parts and 1907. Moulded timber skirting, varnished or shellac finish.	a

Figure 55: Interior looking down the west side of the church, the transept addition can just be seen on the right. The vertical linings and cornice frieze were fitted in 1907, along with the hinged 2 panel vent openings. Source: Photograph KS 2010.

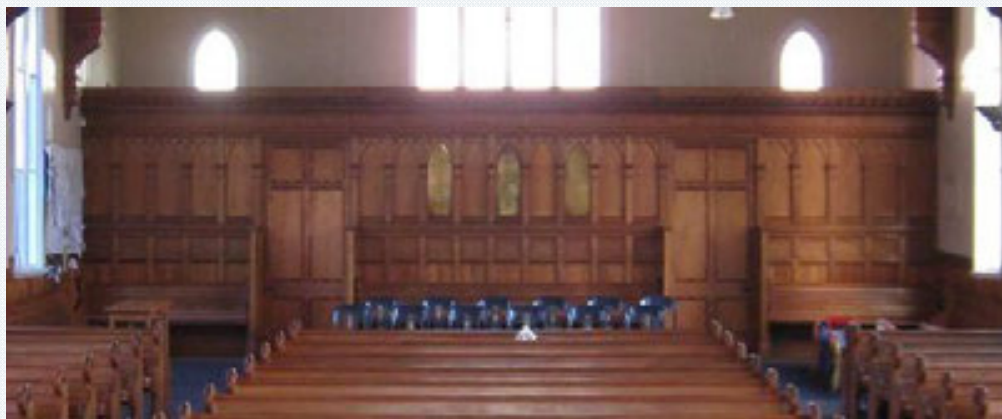
Figure 59: South entrance screen added in the 1907 additions. The low ceiling behind the screen is estimated to have been added in the 1920s. Source: Photograph JM 2010.

Item	Rating
Timber screens, 1907. TG & V dado, divided into vertical panels with stylized quatrefoil detail, pointed arch panels above with cut-out detail, 1907. Historic photograph dated 9 May 1907 shortly after the church opened show that they were in place when the church was opened. They are located near each of the entrances to the church. (Ceilings to these spaces appear to have been added in the 1920s or later.)	a
4x six-panelled timber doors from lobbies into church, c.1907. Original hardware.	a
Three brass plaques commemorating Ministers who have served at St Stephen's, David Runciman, the first Minister of St Stephen's Church 1878- 1889 and members of the congregation who lost their lives in World War I.	a
Ceilings behind screened areas at entrance doors. These appear to be later fabric to the 1907 building and it is estimated that they may have been added in the 1920s or later. These may have been, added to improve the spaces as wind lobbies or for sound protection following introduction of tram service on Jervois Road and the increasing sound from the road becoming a disturbance.	c

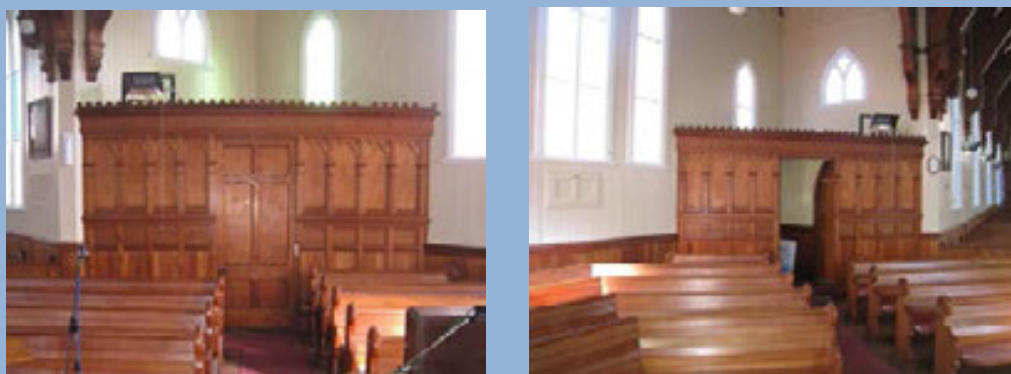
Figure 58: Left: West transept entrance screen. Right: East transept entrance screen. Source: Photographs JM 2010.

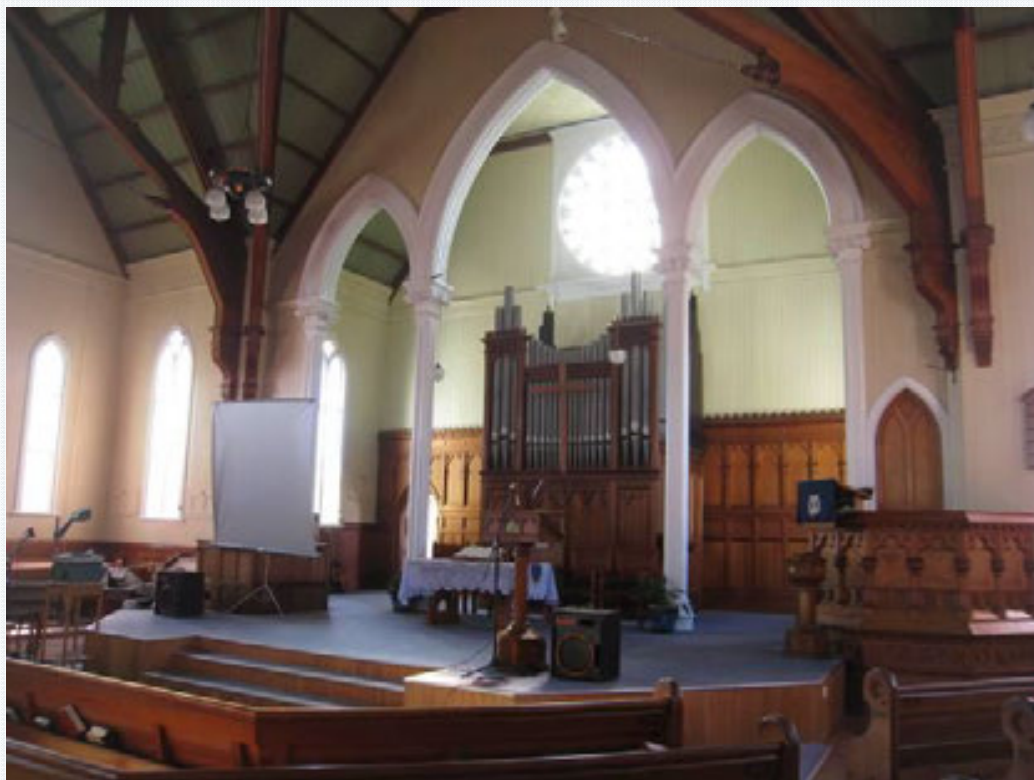
Figure 60: Detail of sanctuary and later 1990s stage area. The organ pipes are on the north wall behind in the sanctuary area. The large tripartite opening with Corinthian columns was built in the 1907 additions when the pulpit was positioned to the east side from its original central position in the 1879 church. Source: Photograph JM 2010

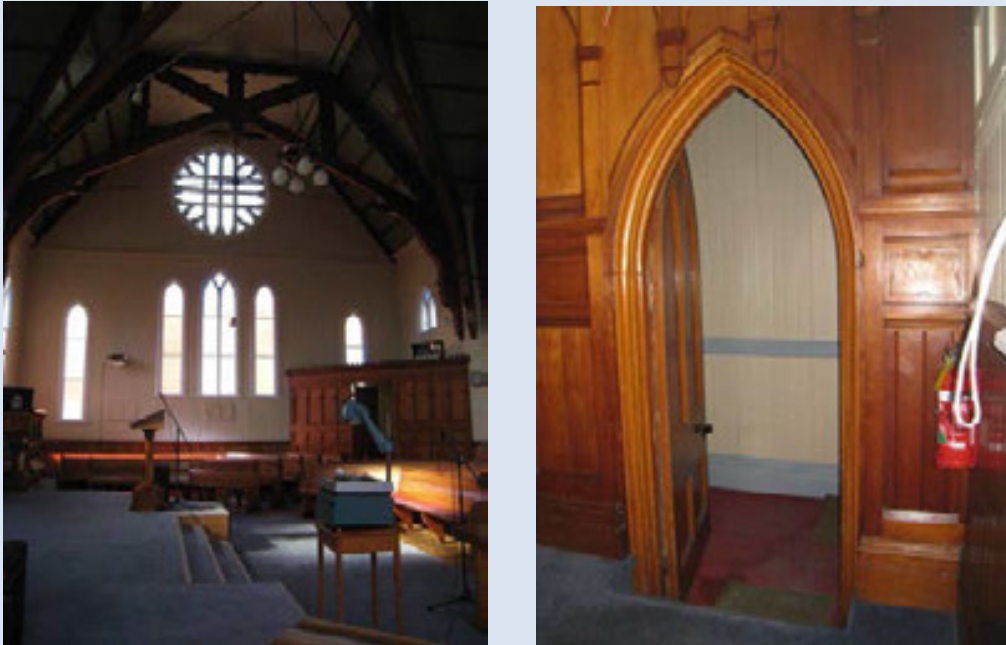
Figure 62: Left: Photograph looking toward east transept, showing the recently fitted stage with steps in the foreground. Right: Door on the east side of the north wall into lean-to, possibly reused from the 1879 building and repositioned in the 1907 additions. There is a matching door on the west side into the vestry office. Source: Photograph JM 2010.

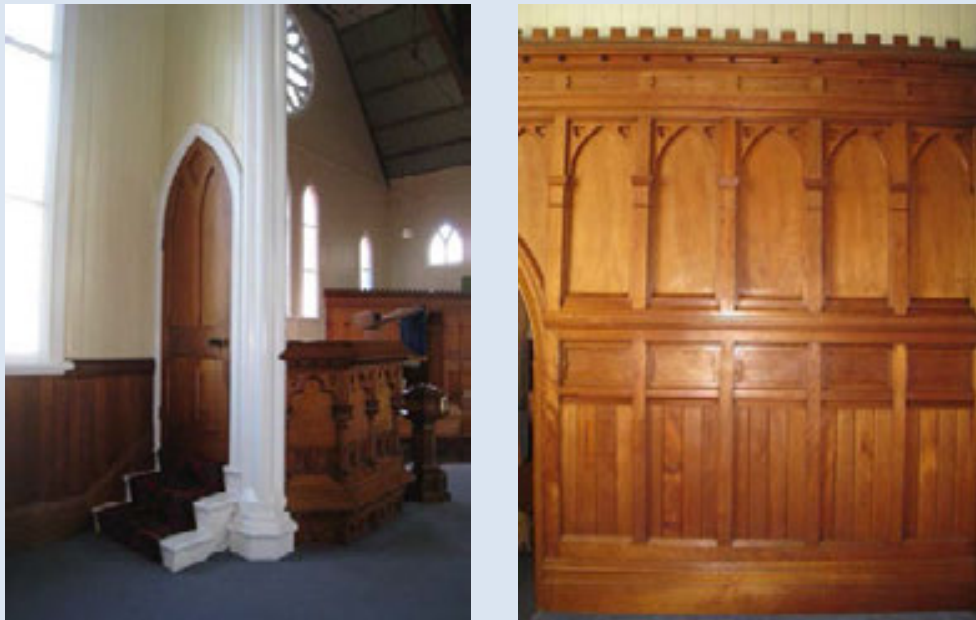
Figure 62: Left: Door and steps to the pulpit area. Right: Detail of the timber panelling on the north wall which matches the timber screens in the church.

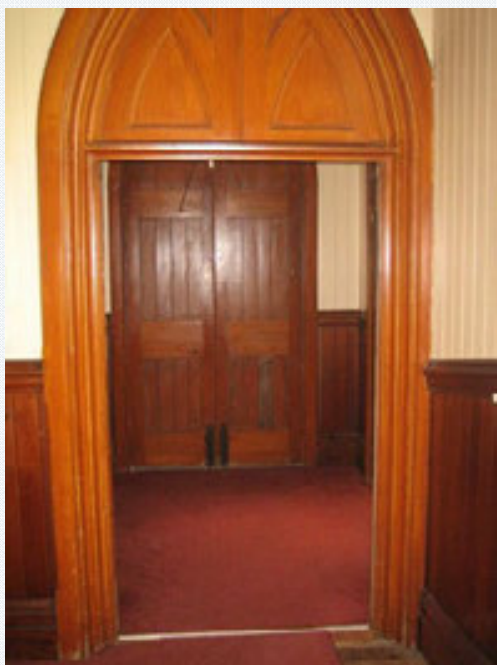
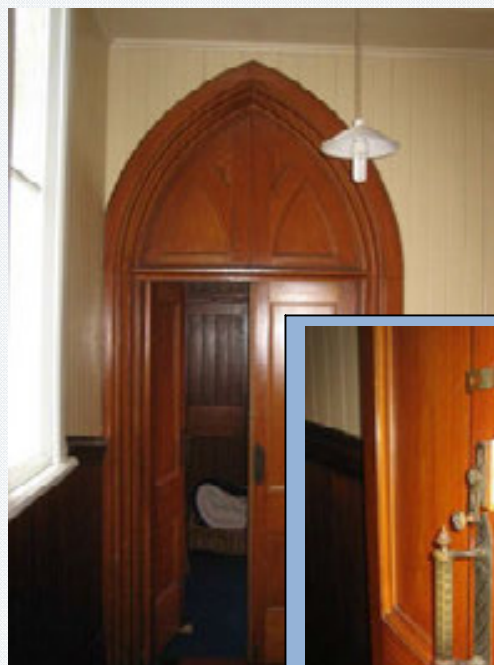
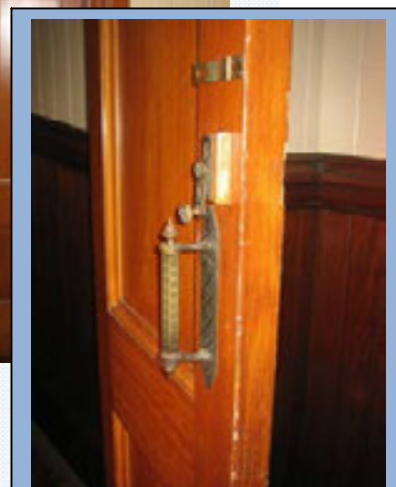
Paired rectangular doors to south wall with pointed arch panel above. Original or early bolts and handles. One drop bolt missing.	a rr

Figure 63: Left: Looking into the east porch at the south end of the church. This shows the dado and entry doors through the opening and the door (1879) from the east porch into the east lobby now behind the screened area. The internal lobby doors on the east side have been removed. Right: Door from west porch (under spire) to west lobby area. Inset: Detail of door handle.

<p><i>Policy 15</i> <i>All original 1879 and 1907 doors and windows should be kept in working condition.</i></p>	<p>The south entry doors are kept shut and have the handles missing. It is recommended that all door and window hardware is refurbished and serviced and missing items replaced so that all opening sections are in good working order.</p>
<p><i>Policy 16</i> <i>Intrinsically valuable original features of the building dating from 1879 and from 1907, including fixtures and fittings, should be protected during any work on the building.</i></p>	<p>Consideration needs to be given to potential damage to the building fabric, fixtures and fittings from dust, fire or water as any work to the building proceeds and adequate protection needs to be ensured.</p>
<p><i>Policy 17</i> <i>Fire protection and security of the site and building should be maintained at all times.</i></p>	<p>There are currently no fire sprinklers in the building. It is recommended that installation of this be investigated, as well as general security of the church, and these should be periodically reviewed.</p>

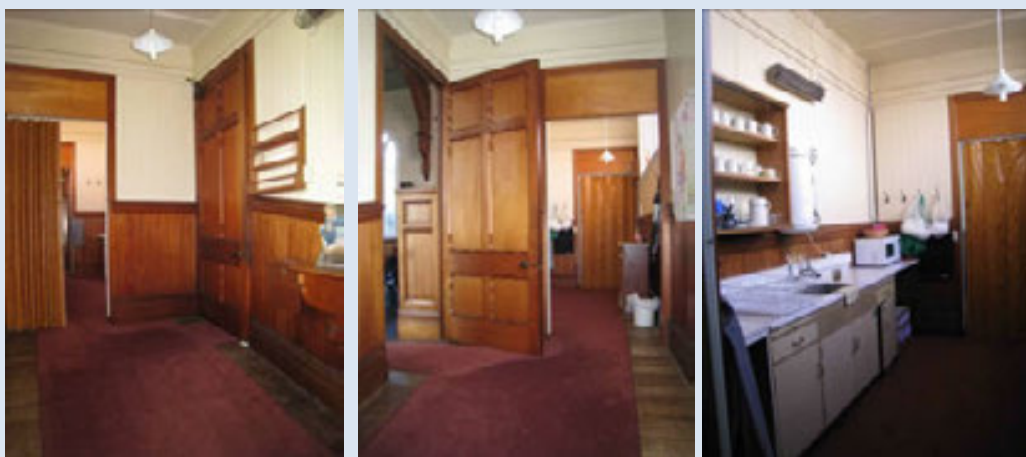
East and West lobbies (between the porch and spire lobbies and the central kitchen area)		B
Ceiling has sheet linings with battens. C. 1920s? with deep plain timber cornice/ frieze.		nil
Walls are vertical TGV with varnished dado and skirting. Wall to church appears to be a later modification; moldings don't align at junction of walls.		b
Timber T&G floor in these lobbies ramps up to level of church floor in centre.		b
Small timber shelf and coat hooks		c
Folding vinyl door from east lobby to kitchen		Int

Figure 64: From Left to right: East lobby, West lobby looking through to kitchenette area, Kitchenette in central area between the two lobbies. Photographs JM 2010.

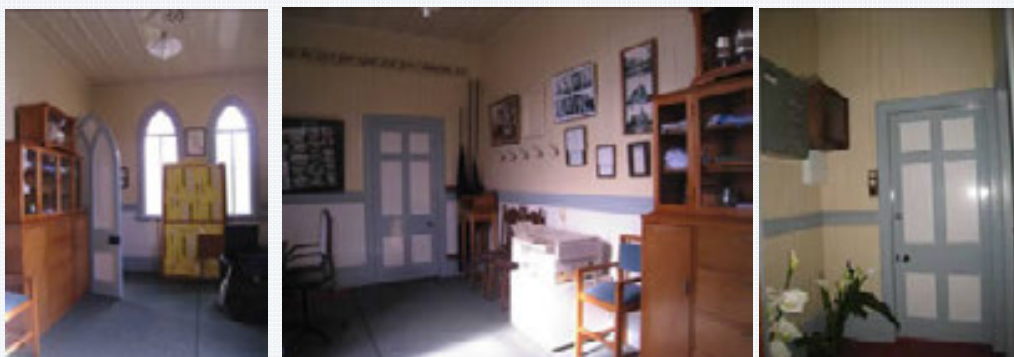
Figure 65: Left and centre: Interior of office. Right: North entrance lobby. Source: Photographs JM 2010.

Item		Rating
North entrance lobby		B
	Ceiling –painted timber board and batten. Walls- painted timber T&G with dado. Timber floor, two steps lower than church floor level.	b
	Door to office, painted 6-paneled door with original hardware.	a
	Door to church with painted timber graining and original hardware.	a
	Carpet tiles over timber floor to lobby.	nil
	Original/early surface mounted conduit and light switches.	b
	Switchboard, alarm panel.	nil
	Small timber cupboard	c

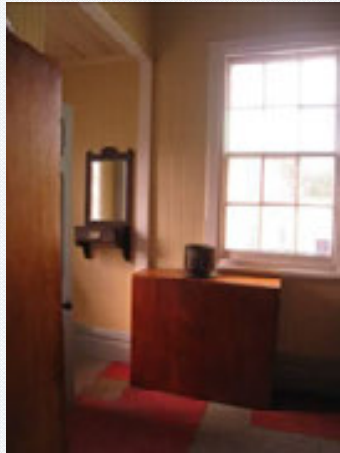
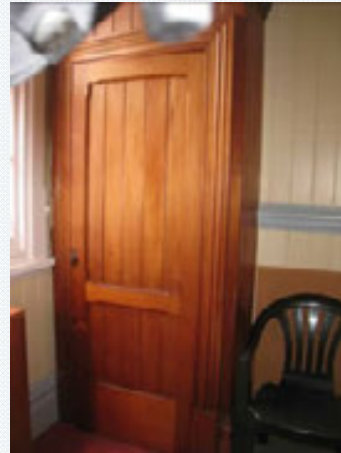
Item		Rating
North vestry	Overall	B
	Painted board and batten ceiling, with original vent	a
	Painted T&G walls with dado molding and skirting	a
	Timber floor with lino tiles	b
	Early/original varnished timber cupboard to south-east corner, coat hooks to interior	b
	Double hung window with 6-light sashes	a

Figure 67: Interior views of vestry. Source: Photographs JM 2010.

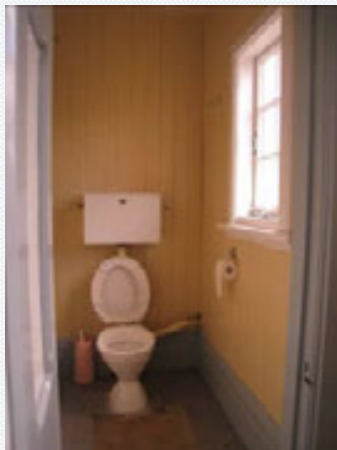
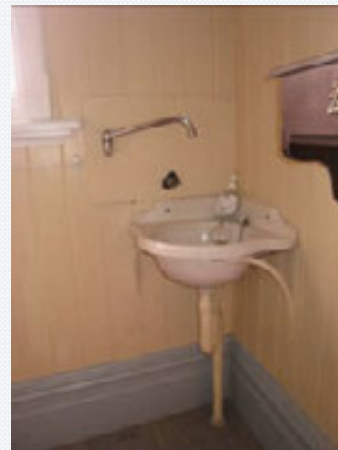
Figure 67: Vestry toilet and hand basin. Source: Photographs JM 2010.

Vestry toilet	Overall	B
	Painted board and batten ceiling	b
	Painted T&G walls with painted timber skirting	b
	2 x small 6-light windows	b
	Painted 6-panel door	a
	Toilet and cistern not original	nil
	Hand basin is early corner mounted porcelain type supported on metal brackets, with visible drainage pipe	a
	Tap not original	nil
